Bamboo structures as a resilient erosion control measure

Tardio, Guillermo; Mickovski, Slobodan B.; Stokes, Alexia; Devkota, Sanjaya

Published in:
Proceedings of the ICE - Forensic Engineering

Publication date:
2017

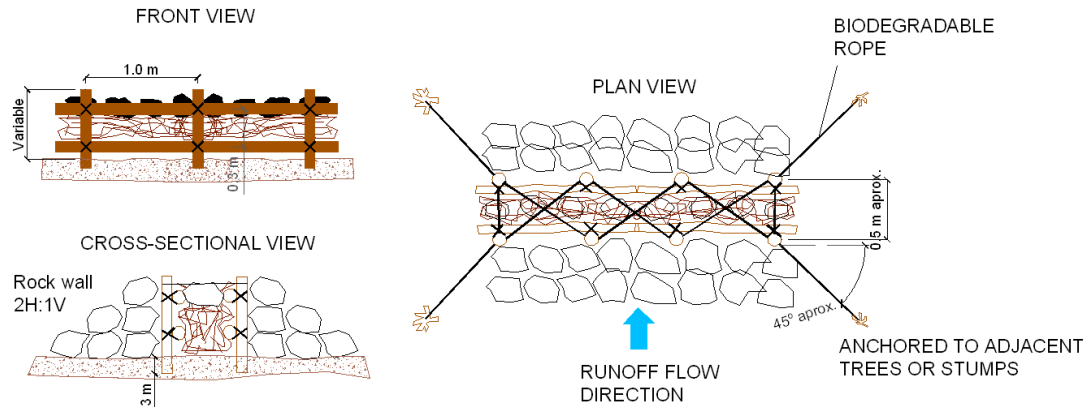
Figure 2 Mixed check dam definition

Due to the magnitude of the wildfire and the resulting risks, the structure was designed to be low-cost, easily and rapidly employable in order to reduce hydrological risks. Similarly to other channel treatments (Norris et al., 2008), its main objective was to reduce water velocity and enhance infiltration and sediment deposition. Designed as a temporary structure, the mixed check dam combined different mitigation techniques such as contour logs, contour trenches and rock dams (Norris et al., 2008). This structure included vegetal debris used as vertical stakes (mainly burned logs of *Erica sp.* and *Myrica faya*), horizontal logs (mainly from burned *Pinus canariensis*), and biodegradable rope to tie the stakes and logs together as a trench and to anchor the whole structure to adjacent trees (Figure 3). The trench was reinforced on the outside by the rock slope to gain stability (less than 50% slope angle), filled on the inside with vegetal debris obtained from silvicultural works, and topped again with rocks (Figures 2 and 3).

The dimensions of the mixed check dam varied depending on the channel width, although always ranging between 1 and 2 m in height and between 8 and 10 m in width (Figure 3B). This structure was used as a principal treatment in ephemeral or small-order channels and as a secondary treatment complementing rock dams and gabions in larger channels. Due to the biodegradable nature of most of the components used, these structures were also designed to facilitate colonization by plants (Tardío-Cerrillo & Caballero-Serrano 2009; Tardío-Cerrillo and García-Rodríguez, 2016) (Figure 3A). The features of this innovative structure included:

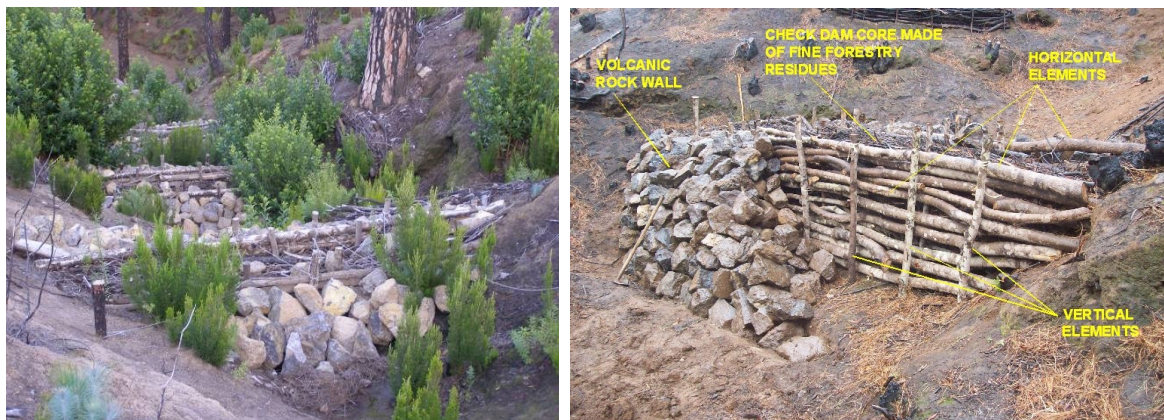
Figure 3 a) Series of mixed check dam colonised by the indigenous vegetation b) Elements of a mixed check dam

- (i) reduction in the channel slope and, thus, water speed and detachment capacity;
- (ii) promotion of infiltration and sedimentation by increasing the sediment storage capacity (mainly large material as vegetal debris or rocks);
- (iii) decrease in resource and time demand by using on-site material for its construction;
- (iv) enhancement of the colonization of vegetation due to the biodegradable nature of most of its components;
- (v) high adaptability of the design and the components to the environment conditions;

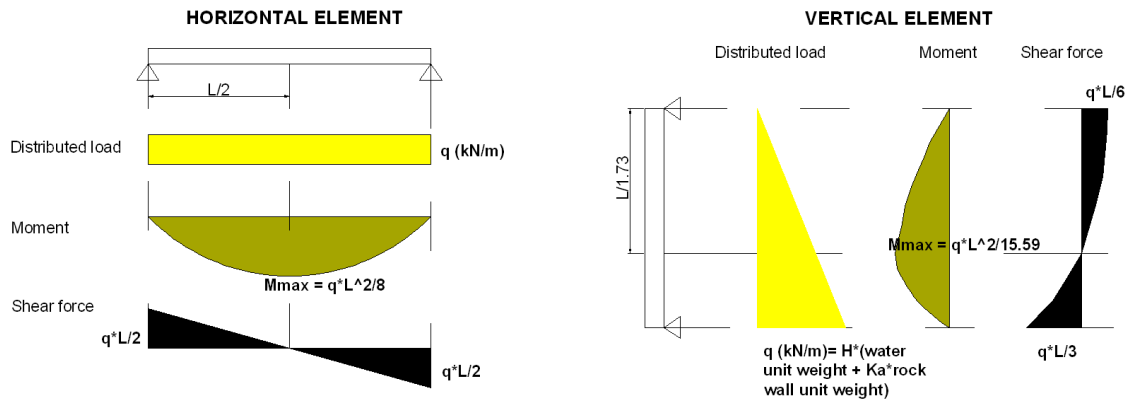
Figure 4 Stress diagrams for the vertical and horizontal elements in a mixed check dam

Both the vertical and the horizontal elements (Figure 4) were modelled as a simply supported beam. The limit state condition in the internal stability check allowed the minimum diameter calculation for both type of elements (Tardio-Cerrillo and Caballero-Serrano, 2009). The horizontal elements were designed as beams subjected to a uniformly distributed load, while the vertical elements were designed as beams subjected to pressures following a triangular distribution shape (Tardio-Cerrillo and Caballero-Serrano, 2009).

With the bending stiffness and the design bending strength in the different loading scenarios, the minimum diameter for both the vertical and horizontal elements were calculated according to Equations 1, 2 and 3. The load and material partial safety factors were determined directly from Eurocode 5 (EN 1995-1-1:2004/A1:2008).

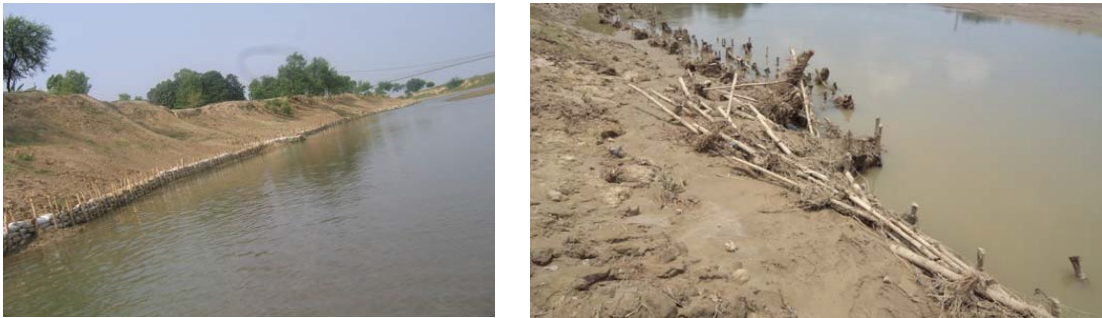
Figure X. Bamboo vanes and vetiver plantation a) before and b) after the flood event

- (i) Most of the bamboo vanes with sand bags placed at the toe of the bank resisted the flood water drag forces.
- (ii) The vetiver saplings were mostly washed away by both the flood water and the surface flow coming from the top of the bank.

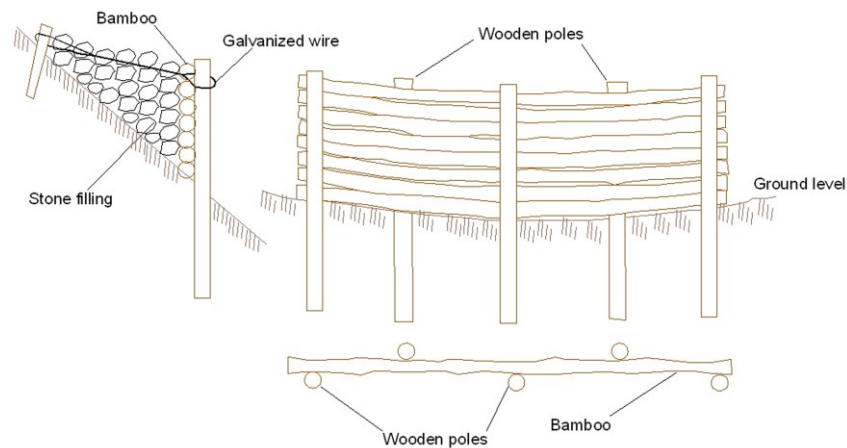
Figure 5 Previous bamboo check dams (according to Sthapit and Tennyson n.d., 2014)

Soil bioengineering has been used widely in Nepal in the past, but the methods currently used have been brought into Nepal over the last 30 years (Schaffner, 1987; Dhital et al., 2012). A traditional technique of close bamboo check dam design in Nepal is shown in Figure 5.

Local reports in Nepal indicate that close check dams do not have a good performance in trapping sediments unlike gridded check dams (Sthapit and Tennyson, 2014) and their design could benefit from an alternative design stemming from the experience with similar structures elsewhere, such as the mixed check dams in Tenerife. Particularly, the main drawback detected in the traditional design was an ineffective debris flow trapping performance. Gridded solutions for bamboo erosion control techniques have been reported as a design improvement of the technique sediment trapping capacity (Sthapit and Tennyson, 2014).

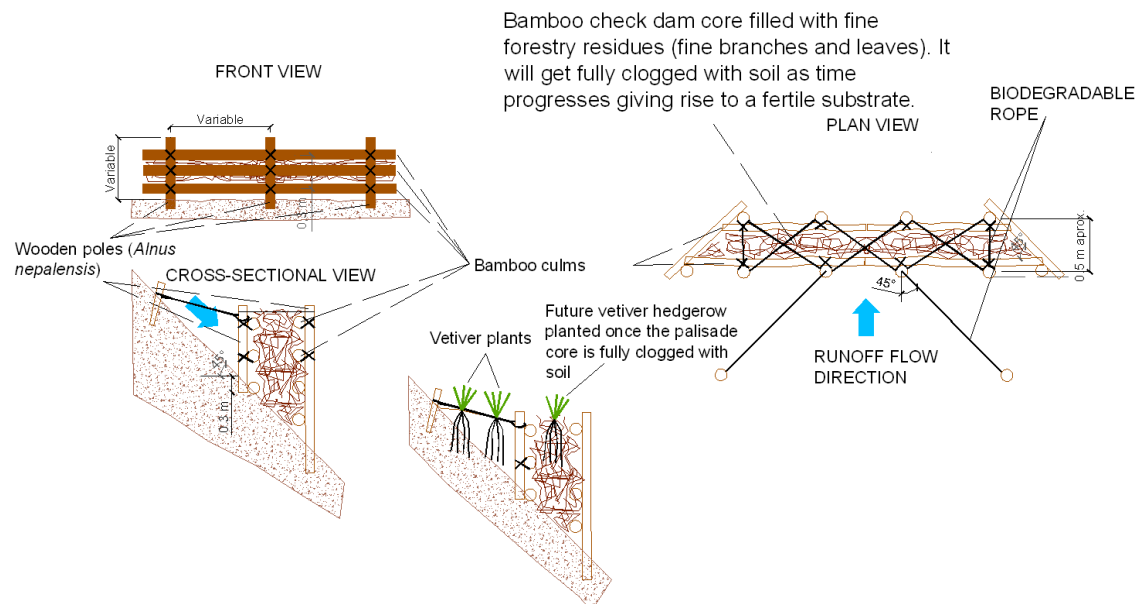
Figure 6 Bamboo check dam general arrangement

Similar to the mixed check dams, the core of the bamboo check dam will be filled with fine forestry or agricultural residues (eg., branches, leaves and grass; Figure 6). All the advantages and successful features of the mixed check dams will thus be incorporated into the proposed bamboo gridded palisade design.
